**Nemi as a laboratory for developing methods for
cultural environments definition and cultural heritage monitoring**

**Case study of Romitorio de San Michele
22-26 July 2001**

Field report

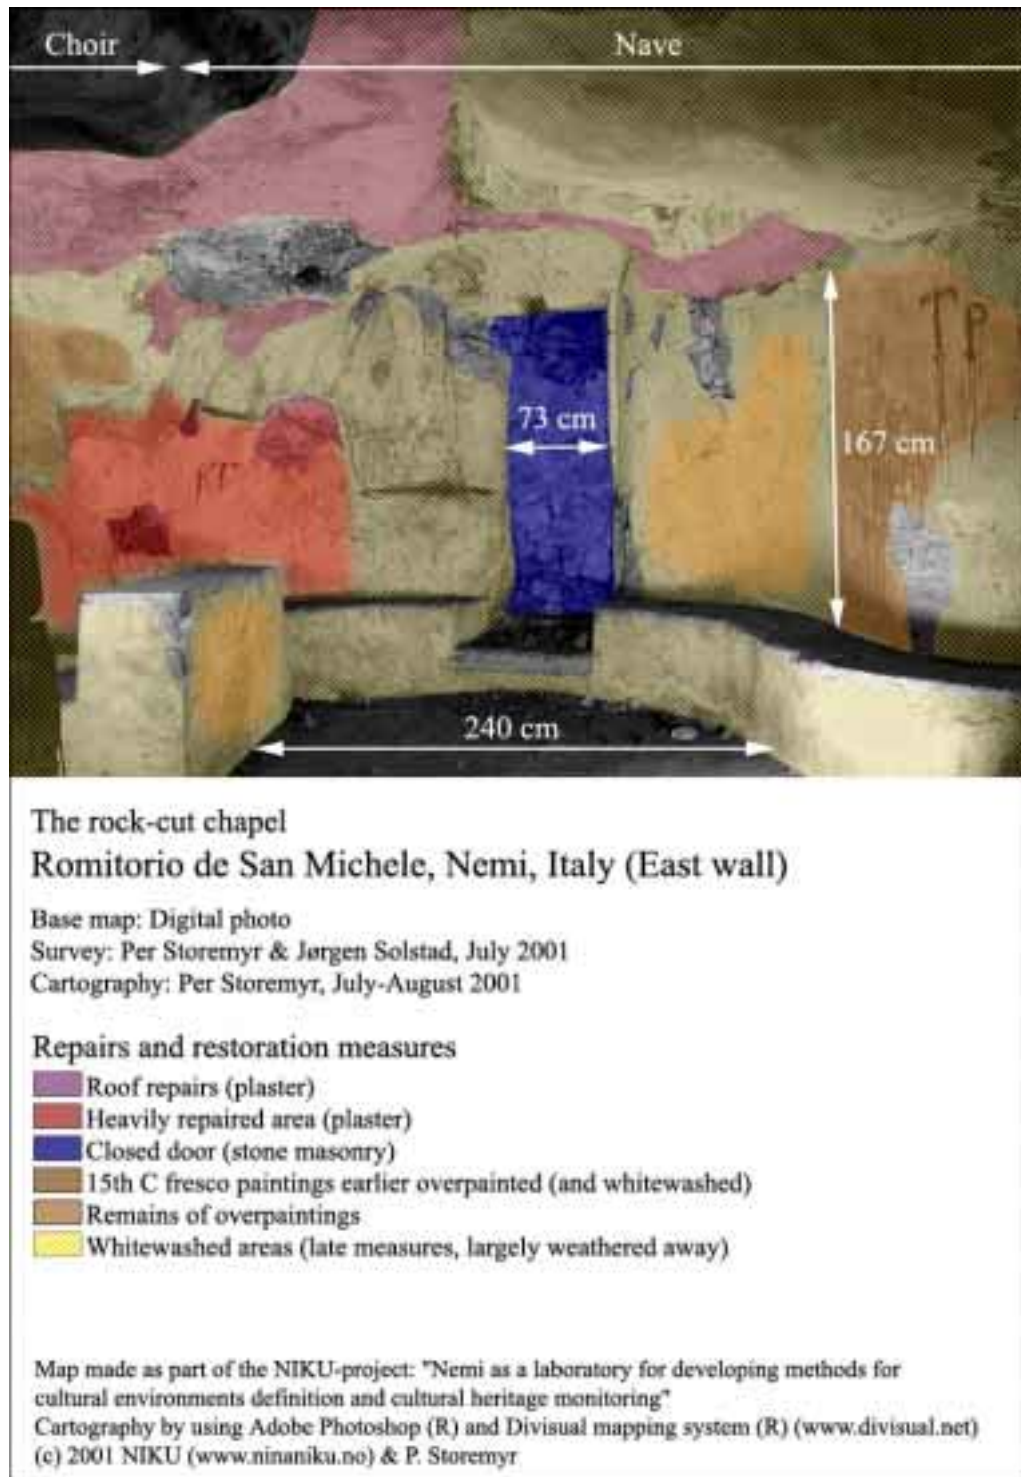
Sketch map of repairs and restoration measures on the east wall

Large plaster repairs are particularly evident on the part of the ceiling made on tuff, as well as on the east wall of the choir and adjacent areas in the nave. Interestingly, these repairs have been executed on surfaces quite close to the cave. Is there a connection with regard to weathering between these features?

The closing of the door in the east wall of the nave must have been a very late measure, probably undertaken well after the chapel was abandoned. This is because the rough masonry has not been plastered and whitewashed. Perhaps the closing must be regarded as a security measure, preventing basalt blocks and masses of earth to fall into the chapel. On the outside towards the cave, the door is almost completely covered by such fallen debris. It might be proposed that this measure, as well as stripping off the whitewash covering the frescos and some of the plaster repairs are restoration measures of the 19th or 20th century.

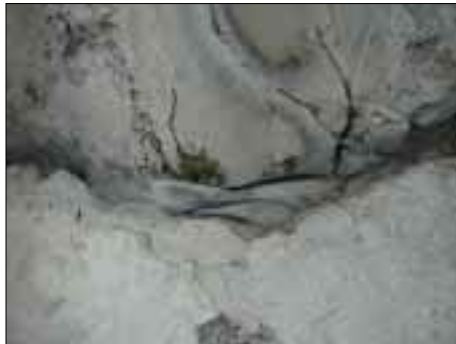
Sharp basalt pieces within the above. Location of photo, appendix 1, no. B

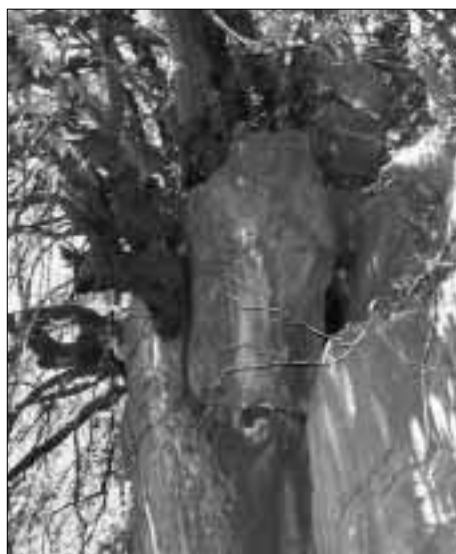
Roots about to burst the basalt in the cliff to the east of the caves

The reason why so many basalt blocks have fallen beside the chapel could be earthquakes, heavy rainfalls (as discussed in the previous chapter) and growing trees and roots. It is impossible at this stage to know in which way earthquakes may influence the situation, but in the near vicinity of the chapel there are many examples of roots bursting the basalt. An obvious measure to avoid root-bursting would have been to keep the vegetation down by cutting at least some of the trees. However, as some roots may keep blocks in place and cutting trees may increase the amount of water entering cracks and the general erosion, it is indeed not a straightforward measure. At the moment the only sensible measure is to monitor the relevant cracks and the general behaviour of the vegetation in order to learn more.

There are several examples of roots bursting the basalt in the near vicinity of the chapel. Whether this is the case also with the *actual* basalt blocks making up the "roof" of the chapel has not been determined. Thus, *a very important aim of further field work should be to map the cliff, its cracks and trees/roots in a detailed manner and to regularly observe how the roots evolve*. Combating crack evolution due to root bursting could be done by regularly cutting the trees in question. However, one would first have to determine whether the actual roots also have a "consolidating" effect on the cliff/blocks. If they have, removing them would demand applying man-made security measures instead.

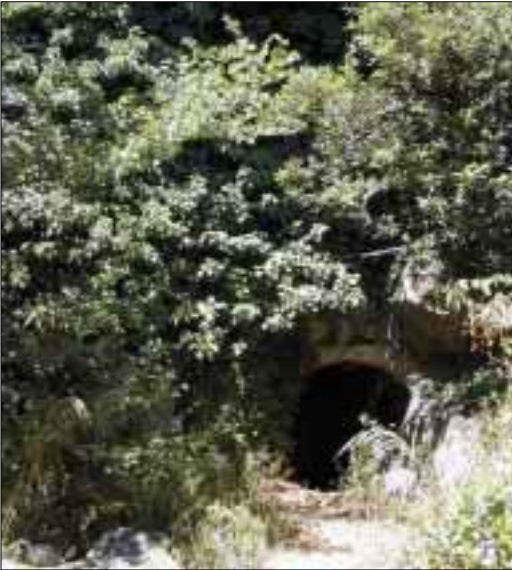
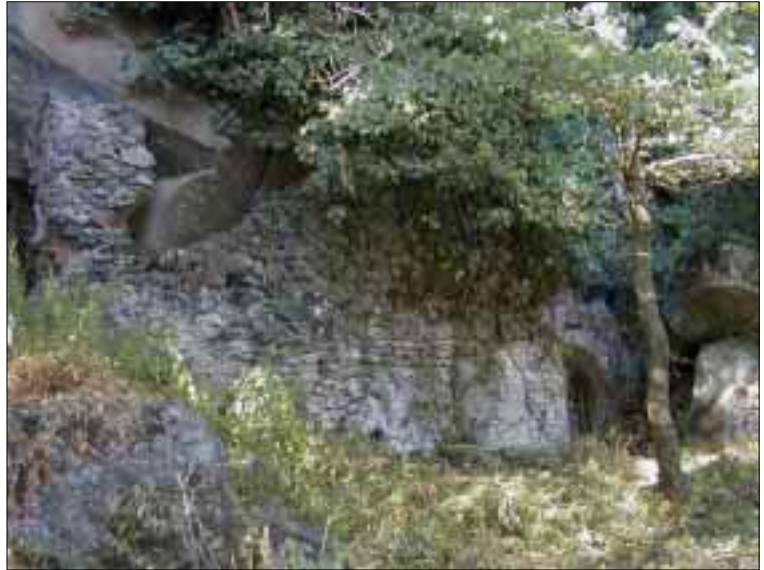
Blocks to the south of the crack are, as mentioned earlier, supported by tuff strengthened by stone masonry. The outer facade masonry possibly also has a stabilising effect. Whereas the former masonry is in good shape, the facade masonry is rather weathered: Many stones have fallen and the mortar is disintegrating. Part of the reason for this is probably ivy-like creepers normally covering the facade (we cleared the facade of the creepers in order to be able to see it). On the other hand, the creepers may prevent rain washing out the mortar.

Right: Photo before clearing the facade of the chapel of ivy-like creepers below branches of trees covering the upper parts. Left: After clearing. Note the condition of the masonry; disintegrating mortar and missing stones, as well as a few cracks.

The ivy-like creepers and other vegetation normally covering the facade of the chapel appear to partly contribute to the disintegration of the masonry. Perhaps the easiest way to control this growth is to make sure the facade is in good shape. This would imply a simple and inexpensive *restoration campaign*; removing all roots, repairing joints and cracks by lime mortar, putting fallen stones back in place and "plastering" the facade using the "pietra rasa" technique.

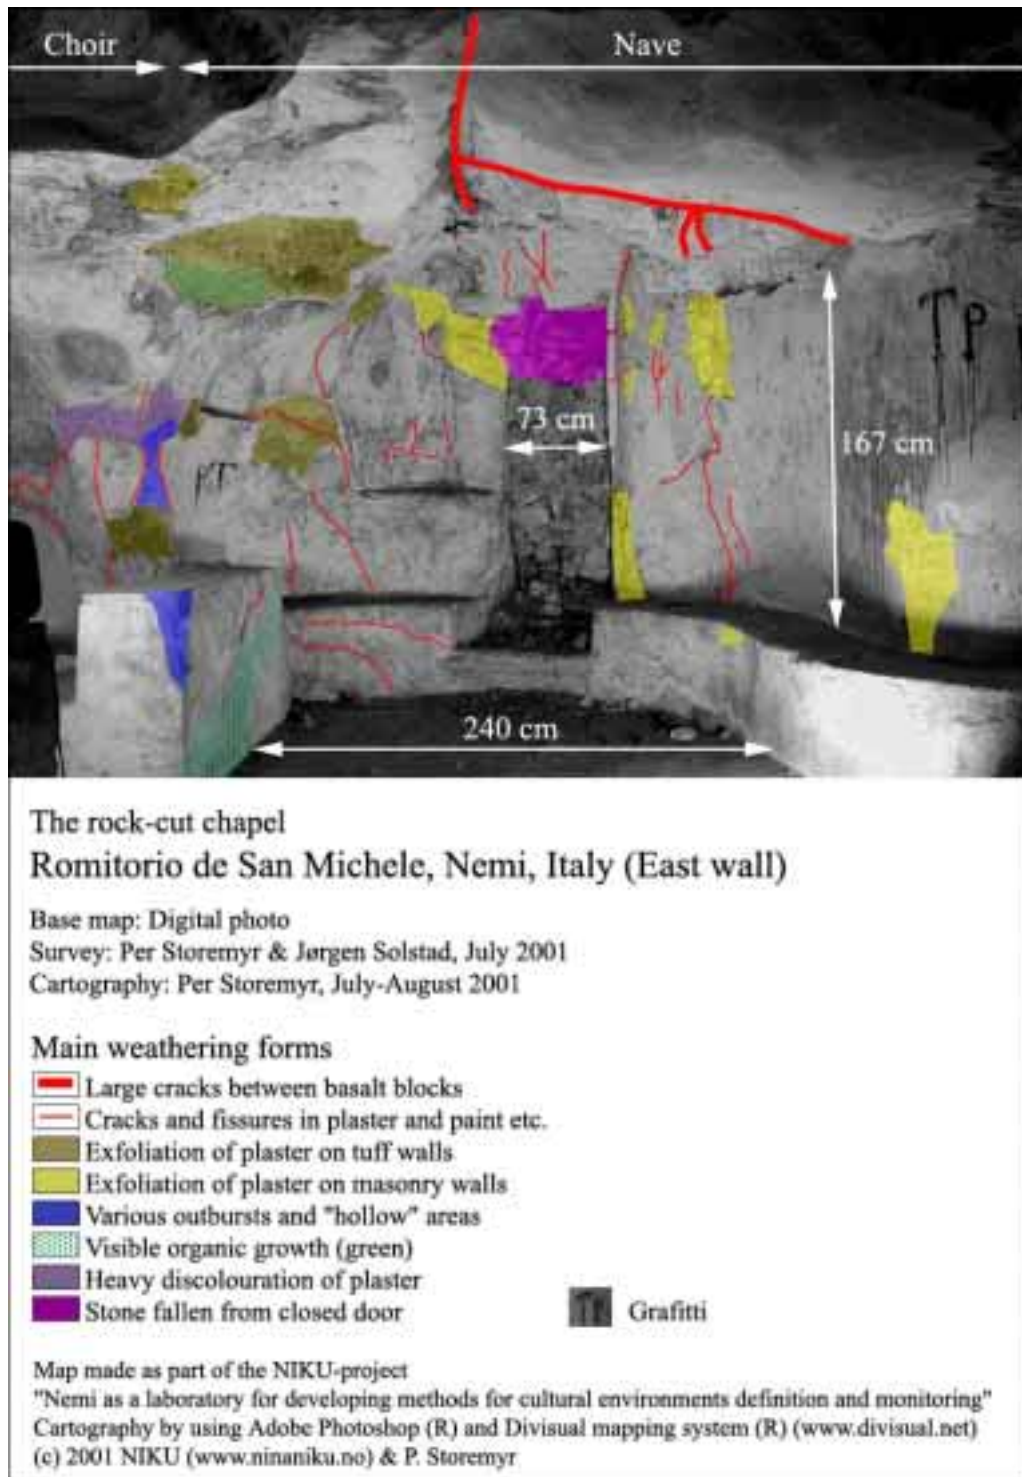
Map of main weathering forms on the east wall of the chapel

At first glance the chapel looks very damaged. Observing the situation more carefully, it appears that the irregular form of the chapel, many colour changes and a few large exfoliations of the plaster make the condition look worse than it is. Also the fact that the room is never cleaned and the decaying heap of leaves by the entrance (because the ground outside is half a meter higher than the chapel floor) adds to the "sad" appearance.

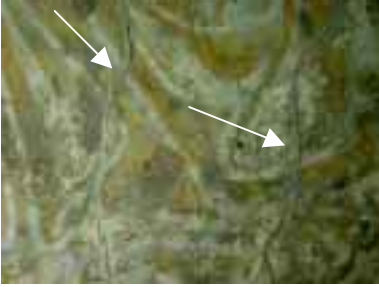
<p>This calcite must come from the plaster and whitewash and indicates occasional <i>very</i> wet conditions in the chapel, either caused by condensation or water leaks through cracks in the basalt, or a combination. The Holy Family fresco has particularly many fissures with recrystallised calcite. The causes of the smaller, relatively harmless fissures can be everything from small-scale stability problems to hygric/thermal expansion and shrinkage.</p>

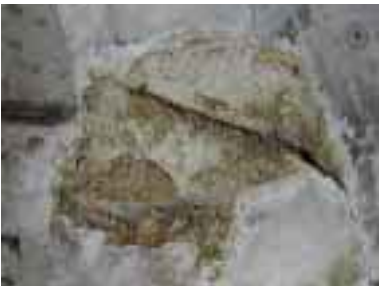
E

<p>Exfoliation of plaster on tuff-walls This is the most significant damage in the chapel (except from large cracks described above). It occurs on tuff walls, especially on the east side, and in the part of the ceiling having tuff. At such places the tuff normally is covered with large amounts of what appears as salt efflorescences and salt crusts, but that upon closer examination mostly turns out to be cauliflower calcite crusts (samples 2 & 7, appendix 1). Unknown, complex salts can however also be found in such areas (sample 1). Again, the occurrence of calcite points to occasional <i>very</i> wet conditions in the chapel. Below the Holy Family fresco, as well as in parts of the roof it is evident that the exfoliation is a recurrent phenomenon, reappearing after repair measures. These areas are in other words specific problem areas. The causes must probably be sought in water drainage patterns.</p>

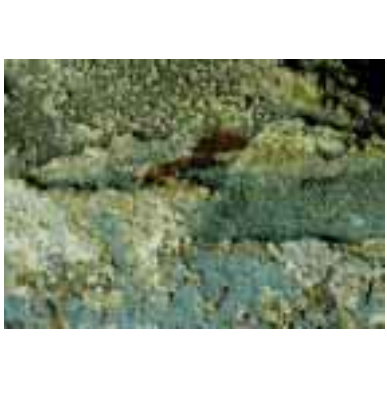
<p>Visible organic growth</p> <p>There is less visible organic growth in the chapel that one would have expected in such a moist environment. Although samples have not yet been analysed, it seems that green algae is the main constituent of the growth. It can especially be found on the ceiling, along the floor and on the altar marble elements. A special case is loc. H, where the growth appears as moss to the naked eye. However, analysis of sample 7 (appendix 1) shows that it is rather algae occurring on and within cauliflower calcite crusts.</p>
I

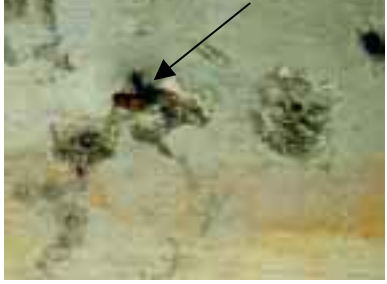
<p>Outbursts around nails</p> <p>This is a very peculiar damage form, occurring especially on the frescos in the choir. <i>Hundreds of nails have, for unknown reasons, been hammered into the plaster</i>, giving rise to outbursts upon rusting of the nails. There are few rusting nails remaining, implying that this damage form is no longer very active.</p>

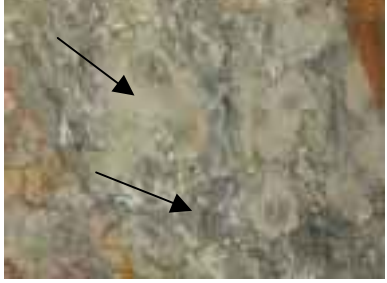
J

<p>Discoloration</p> <p>Discoloration is the main weathering form of the otherwise very well-preserved frescos in the choir. The phenomenon also occurs on plastered tuff walls. On the frescos it appears as stable, grey areas, as if the pigments have been "washed" away only. At the moment we cannot explain this weathering phenomenon, but it would seem that it is connected to occasional very wet conditions, since the areas often have the form of "wet spots". It is probably not possible to get a grip on this weathering form without investigating the chapel in a moist period.</p>
K

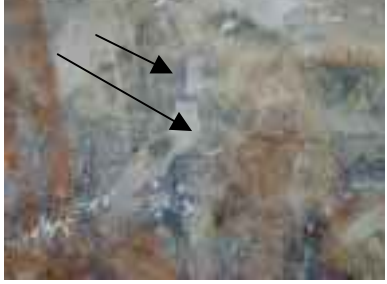
<p>Although the grey areas seem relatively stable, one cannot rule out the possibility that the discoloration phenomenon is a very active one, thus representing the main threat to the frescos.</p>
L

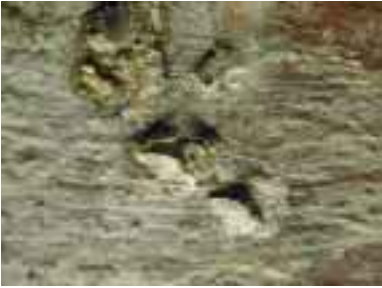
M

<p>Flaking of whitewash and paint</p> <p>This is a weathering form of very limited distribution. It occurs at a few places on the masonry wall close to the entrance and on the Saints' Row fresco, and is always followed by powdery salt efflorescences. However, the salt appears to be gypsum only and not more strongly hygroscopic ones (sample 10, appendix 1). The general absence of hygroscopic salts in the chapel may point in two directions: They might simply not be present, or the conditions might be too moist for them to frequently crystallise. Only complete salt analyses of the building materials (tuff, plaster) can give an answer to this question. A preliminary analysis of the tuff (sample 5) indicates that the salt content (anions) of the tuff is low.</p>
N

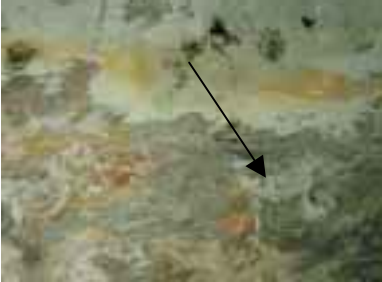
O

<p>Fragments of whitewash on frescos</p> <p>Whether the many fragments of whitewash on the frescos should be regarded as a damage can be discussed. It is however important to note that the removal of the whitewash appears not to have caused much mechanical damage to the frescos.</p>

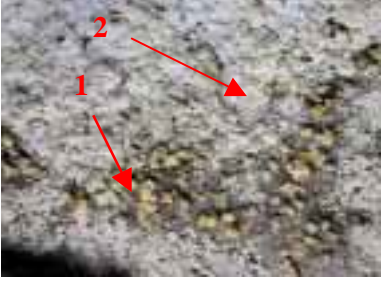
<p>1: Cauliflower crust on tuff (yellowish on picture). Large grain-masses in microscope, pinkish to greenish, almost isotrope. No effervescence. in 10% HCl, sol. in water - gives milkwhite solution. pH c. 8, Very much SO₂, Cl and NO₃. Unknown salt.</p> <p>2: White, powdery mass. Small grains with high interference colours in microscope, effervesce in 10% HCl, pH c. 7, No SO₂, Cl or NO₃. Probably calcite</p>	1: XRD
3

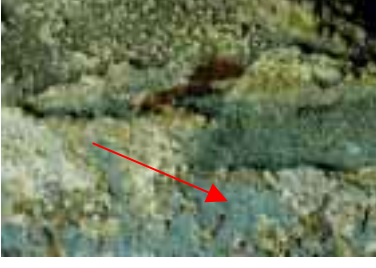
<p>Very green layer on tuff and white crusts. Sample taken for microbiological analysis. The green layer is on and within a crust of calcite (tested in microscope and with HCl). There is also a white, powdery salt with the optical properties of gypsum in the area</p>	<p>Microbiological analysis</p>
8

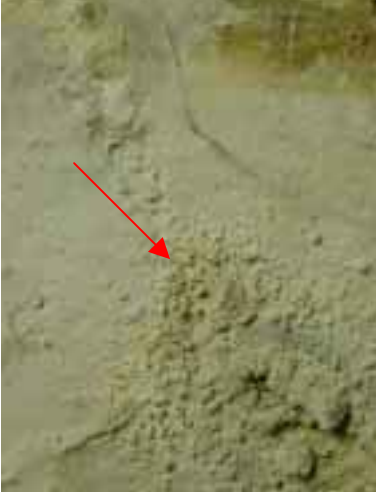
<p>Cauliflower, relatively hard crusts on plaster/whitewash. Effervesce in HCl, probably calcite</p>	
9	<p>No picture</p>	<p>Large area with green, moss-like biological growth</p>	<p>Microbiological analysis</p>
10

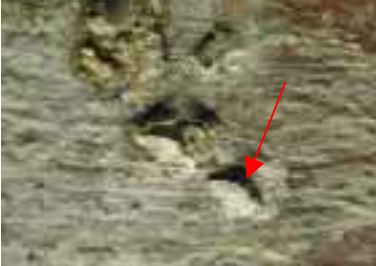
<p>Powdery salt efflorescences below paint layers that are about to flake off. In the microscope the optical properties of the salt resembles gypsum.</p>	<p>Further salt analysis (microchemistry)</p>

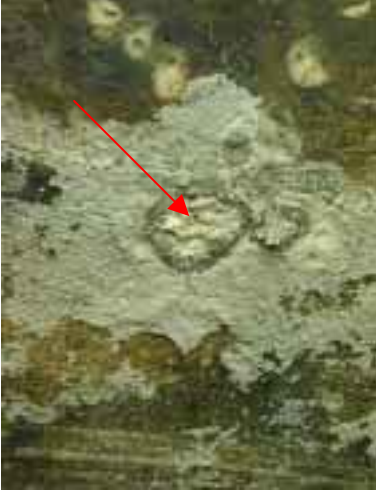
<p>Powdery salt efflorescences. In the microscope the optical properties of the salt resembles gypsum.</p>	
13
