**Nemi as a laboratory for developing methods for
cultural environments definition and cultural heritage monitoring**

**Case study of Romitorio de San Michele
22-26 July 2001**

Field report

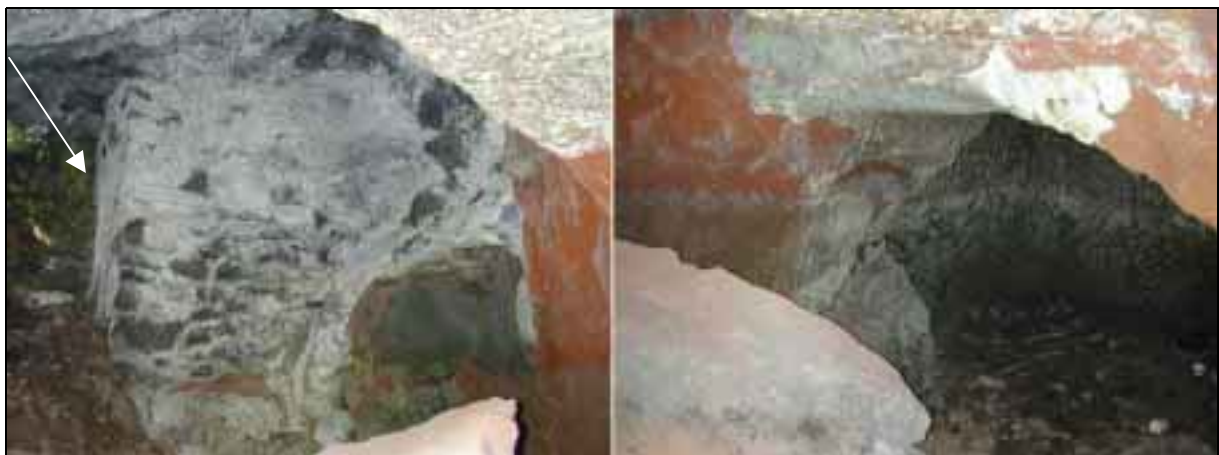
The westernmost cave. Left: West side close to entrance with masonry structure. Arrow indicates the location of the former door to the chapel. Right: Interior of the westernmost cave. Red colour is probably algae.

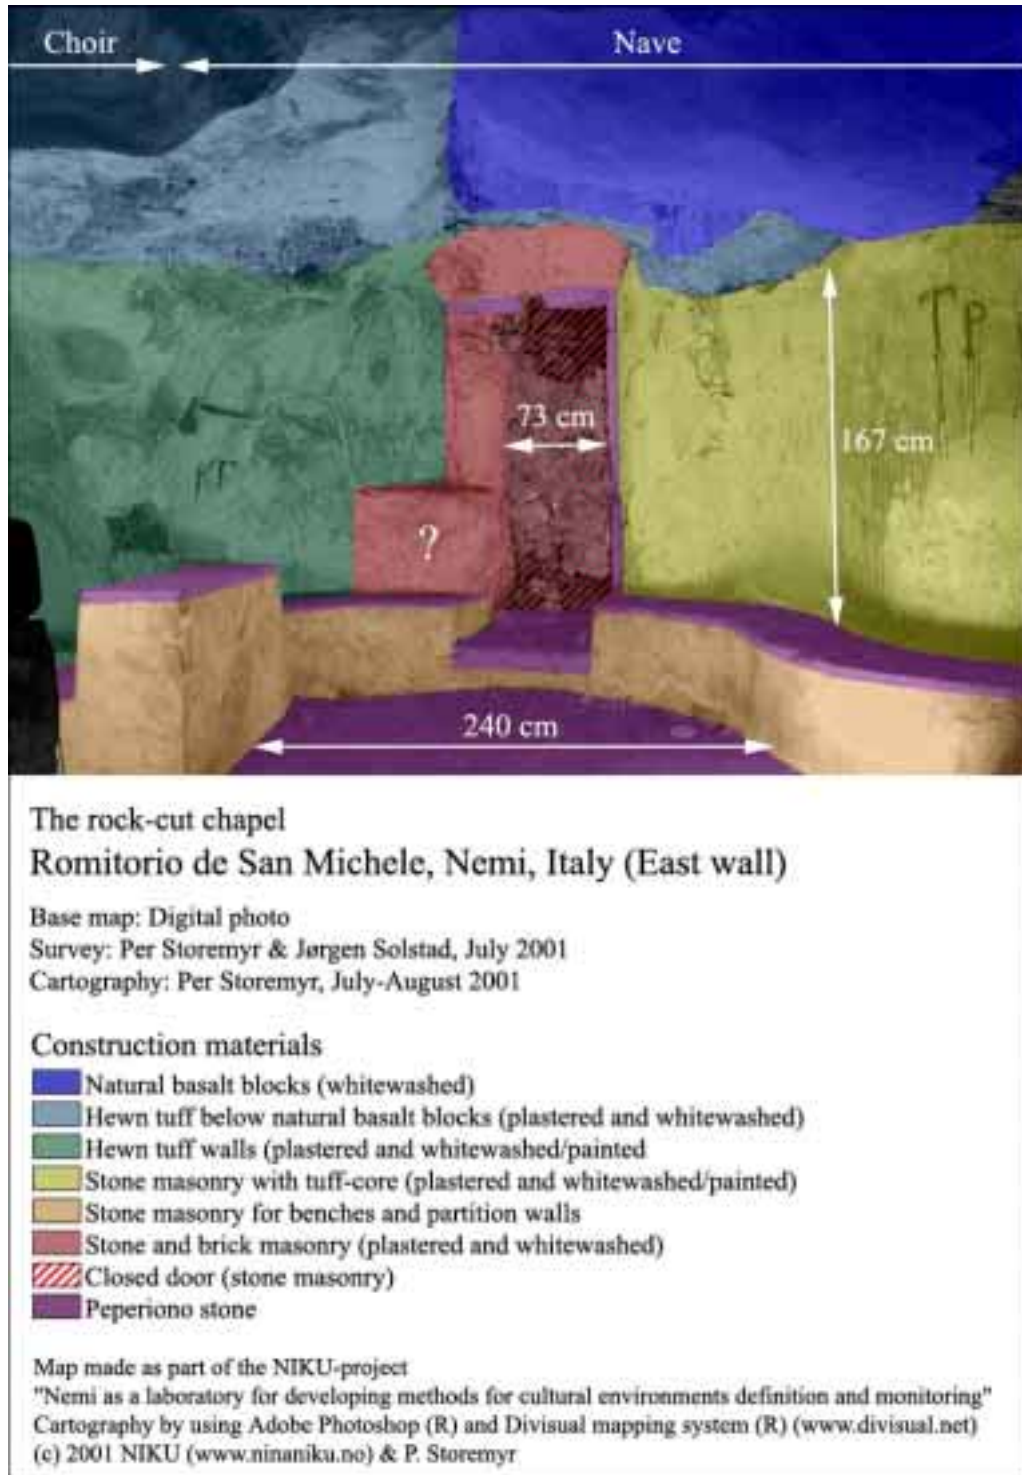
Map of construction materials on the east wall of the chapel

The whole choir and most parts of the nave have plastered tuff walls, but in the south-eastern part of the nave the tuff is strengthened by apparently rather irregular, plastered stone masonry, giving the wall a semi-circular appearance. Plastered stone masonry can also be found around the entrance to the chapel, which has a semi-circular arch and is permanently closed by a gate made from iron bars, as well as around the blocked door to the cave. The masonry used to block the door is very irregular and unplastered.

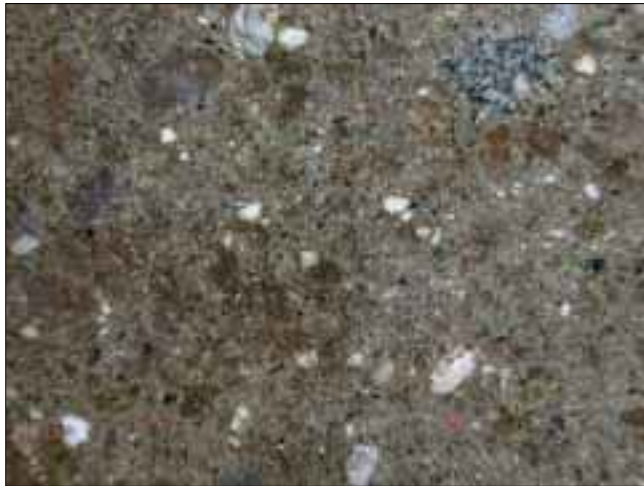
Peperino stone on the floor of the chapel with its characteristic speckled appearance (width of field c. 10 cm)

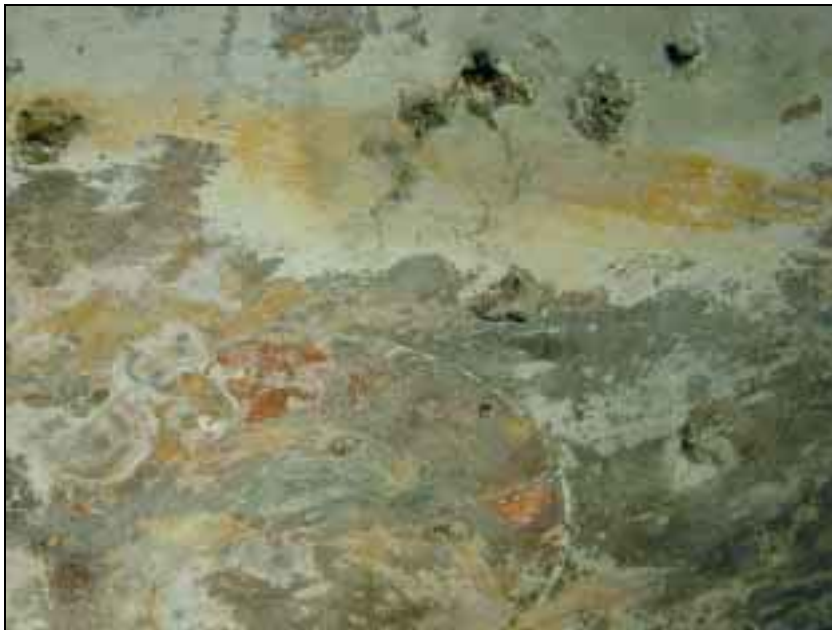
*Middle:
The yellowish line above the
Crucifixion is painted (in
fresco?) on whitewash having
covered also the fresco.*

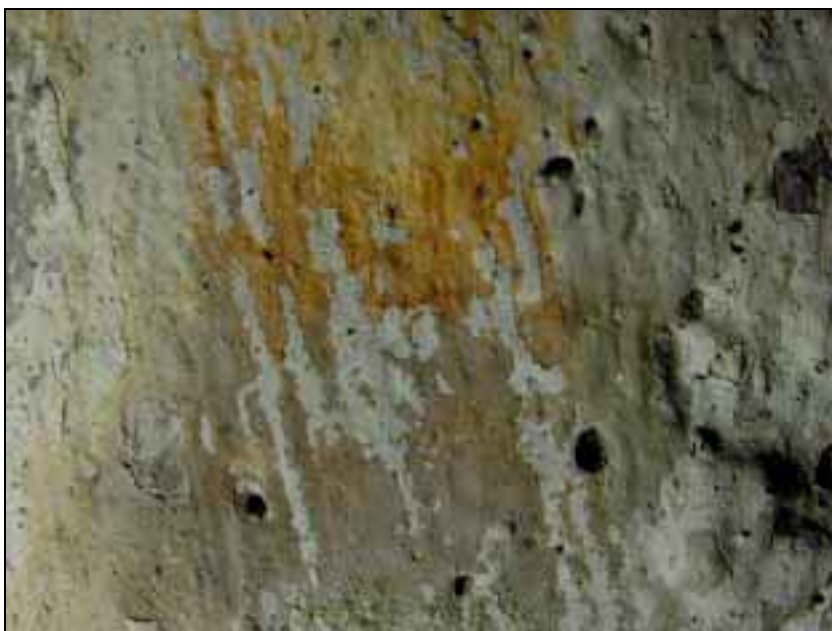
*Below:
Detail from the north side of
the Crucifixion showing that
the yellowish secondary paint
has been covered by a layer of
whitewash*

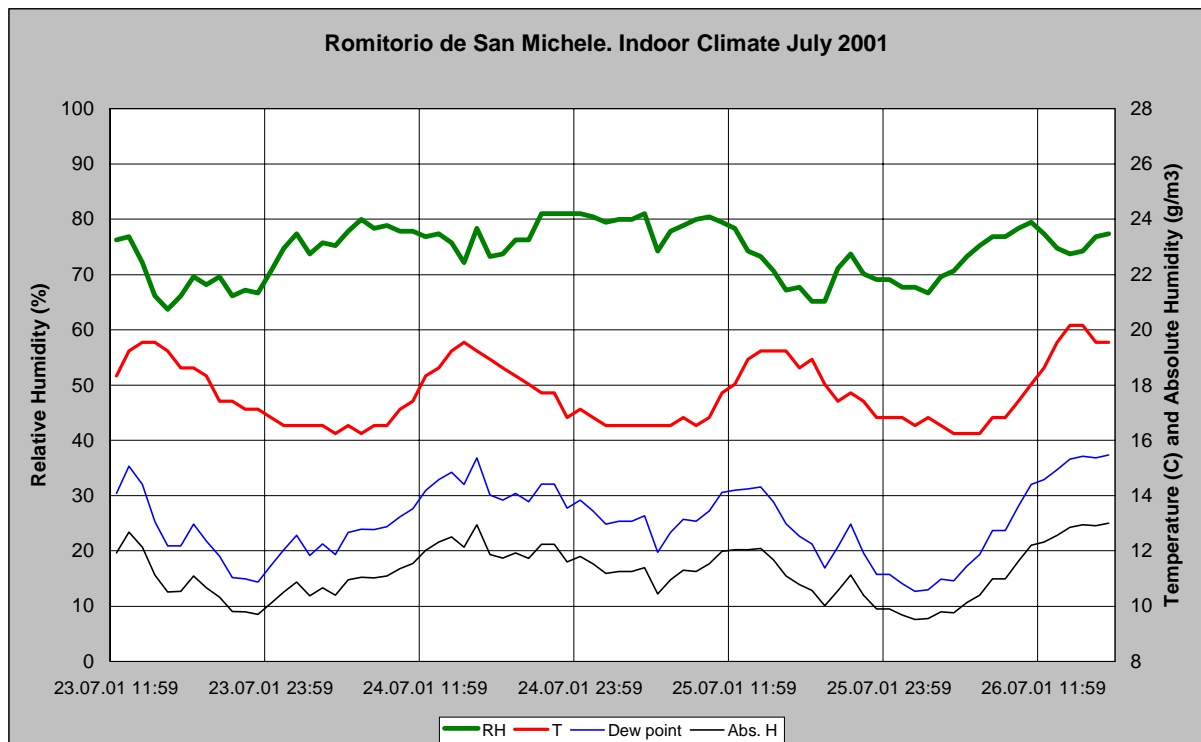
Temperature and relative humidity in the chapel (hourly values). Tinytag Ultra datalogger. Measured 10-15 cm below the ceiling in front of the Altar

In the fieldwork period, during which the weather was hot and sunny (max. c. 30°C), we recorded temperature and relative humidity in the chapel on an hourly basis. The difference between night and day (T: 16-20°C, RH: 80-65%) is probably even more marked in spring and autumn when nights are generally colder and days often warm.

Of specific interest for the weathering in the chapel is condensation events. During our short field work period we did not observe dew on the walls, and as can be seen from the diagram above the dew point is generally 3-4°C below the room temperature. Since many signs of condensation events can be observed in the chapel (lime crusts and other patterns of small amounts of running water), it may be assumed that heavy condensation events do occur, probably mostly in autumn and spring. However, one cannot rule out the possibility that signs of running water along the walls may also be caused by precipitation, especially in the autumn period when the ground may reach saturation. Fractures in the basalt cliff would in this case form the drainage channels.

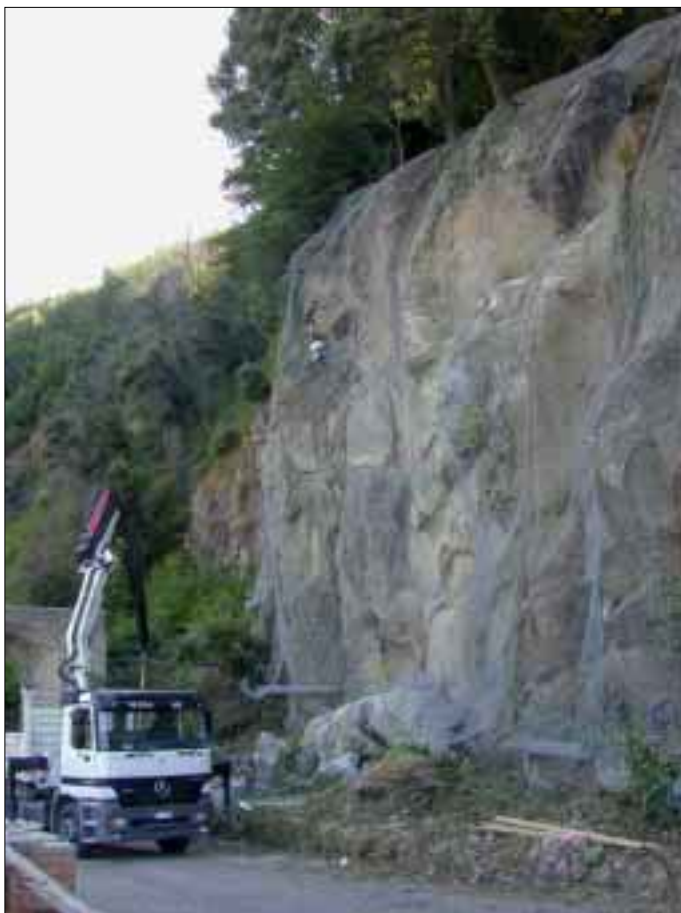
The cliff above the chapel is not the only basalt cliff around Nemi having stability problems. Fallen blocks can be observed all over the place and a very notable example can be found at the high cliff just by the Nemi town gate.

During our field work period workers were stabilising the cliff by removing loose blocks and applying a metal net to avoid more blocks falling: The cliff is situated by the much used path leading down to Nemi lake and falling blocks may have disastrous consequences.

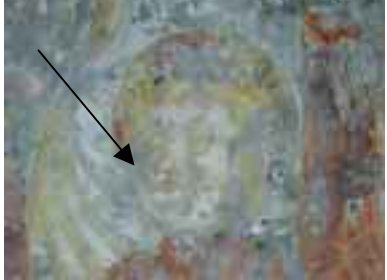
M

<p>Although the grey areas seem relatively stable, one cannot rule out the possibility that the discoloration phenomenon is a very active one, thus representing the main threat to the frescos.</p>
L

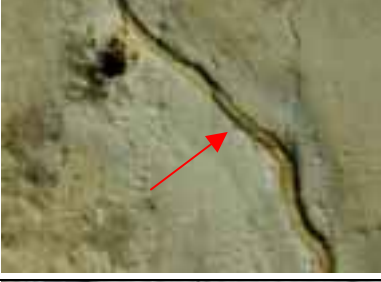
Hard, fine small crystals with high interference colours, effervesce in 10% HCl. Probably calcite .	
4

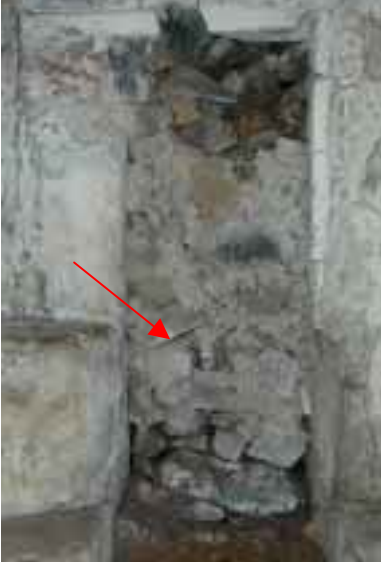
Mortar from blocked door. Not analysed	Full mortar analysis, also in order to check for cement (for "dating" the mortar)

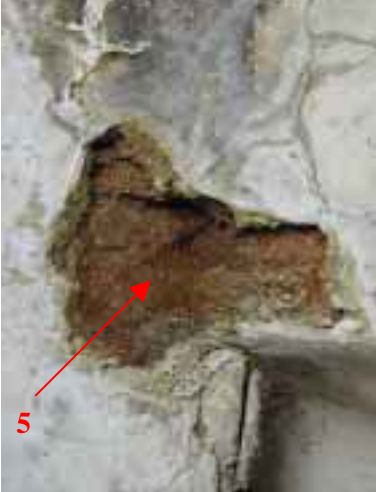
5 and 6

<p>5: Tuff "powder". None of the minerals effervesce in 10% HCl, traces of SO₂, Cl and NO₃</p> <p>6: Mortar from area around "outburst" (had fallen down). Not analysed</p>	<p>5: XRD for mineralogy and full salt analyses for understanding the "background" soluble salt level.</p> <p>6: Full mortar analysis</p>
7

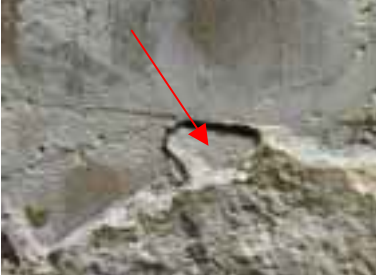
11

<p>Small piece of plaster with paint from the Saint's Row. Under the stereo microscope it seems that the upper layer is more a crust than a paint layer, indicating fresco technique</p>	<p>Polished section, microscopy</p>
12

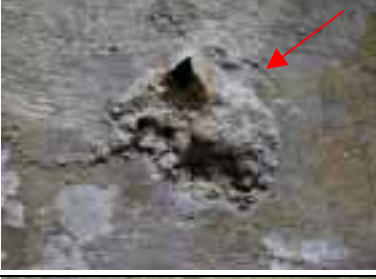
<p>Small piece of plaster with paint from the Crucifixion. Under the stereo microscope it seems that the upper layer is more a crust than a paint layer, indicating fresco technique</p>	<p>Polished section, microscopy</p>
14

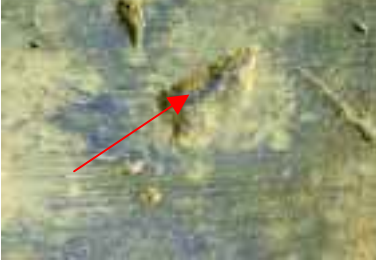
<p>Small piece of plaster with blue paint from the Altar picture</p>	<p>Polished section, microscopy and pigment determination (in order to "date" the blue pigment)</p>
